**State of Louisiana
Department of Natural Resources
Coastal Engineering Division**

**2005/2006 Annual Inspection
Report**

**SABINE REFUGE PROTECTION
PROJECT (CS-18)**

October 27, 2005
Cameron Parish

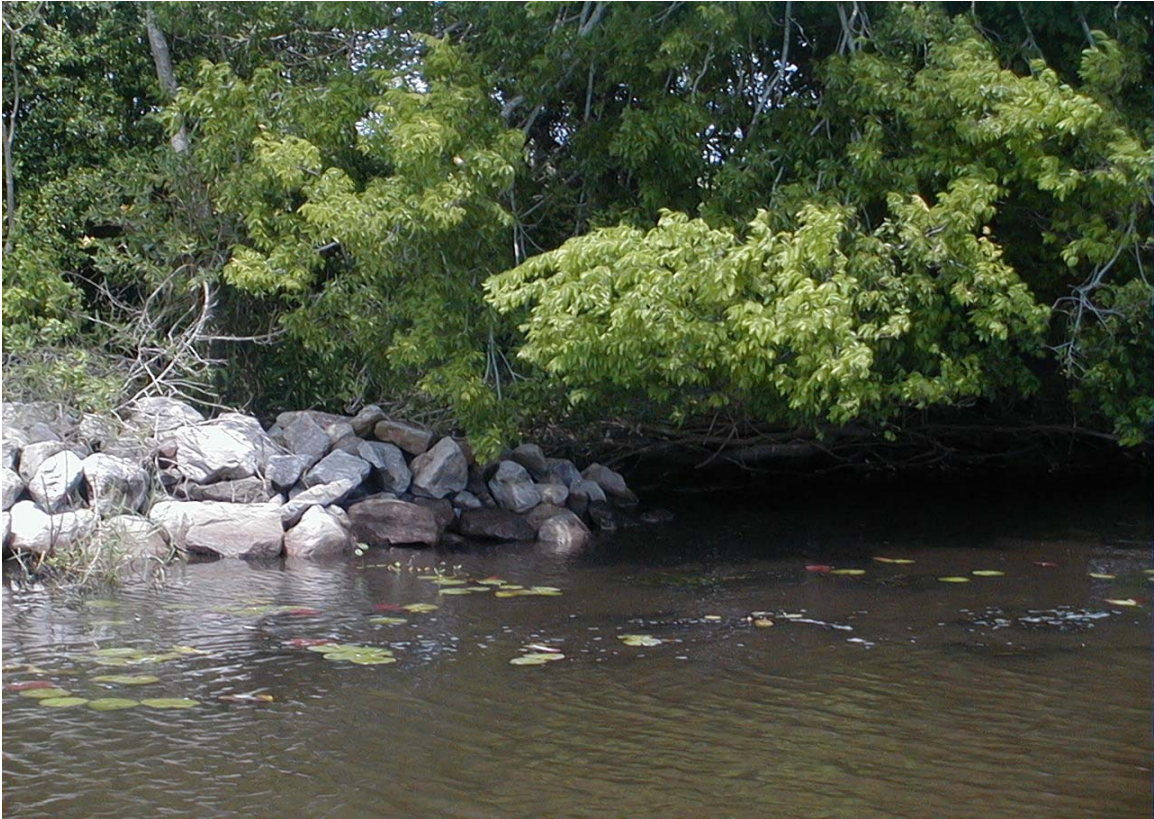
The rock breakwater along the Burton Sutton Canal was the only dike inspected due to Hurricane Rita debris field. The storm surge was estimated to be +7.0 NAVD88. There was some organic material deposited on the rocks. The dike is in excellent post construction condition. No need for any maintenance in the foreseeable future. (Photos: Appendix B, Photos 1 - 2)

Photo 1—southern tie-in on Burton Sutton Canal (April 21, 2005)

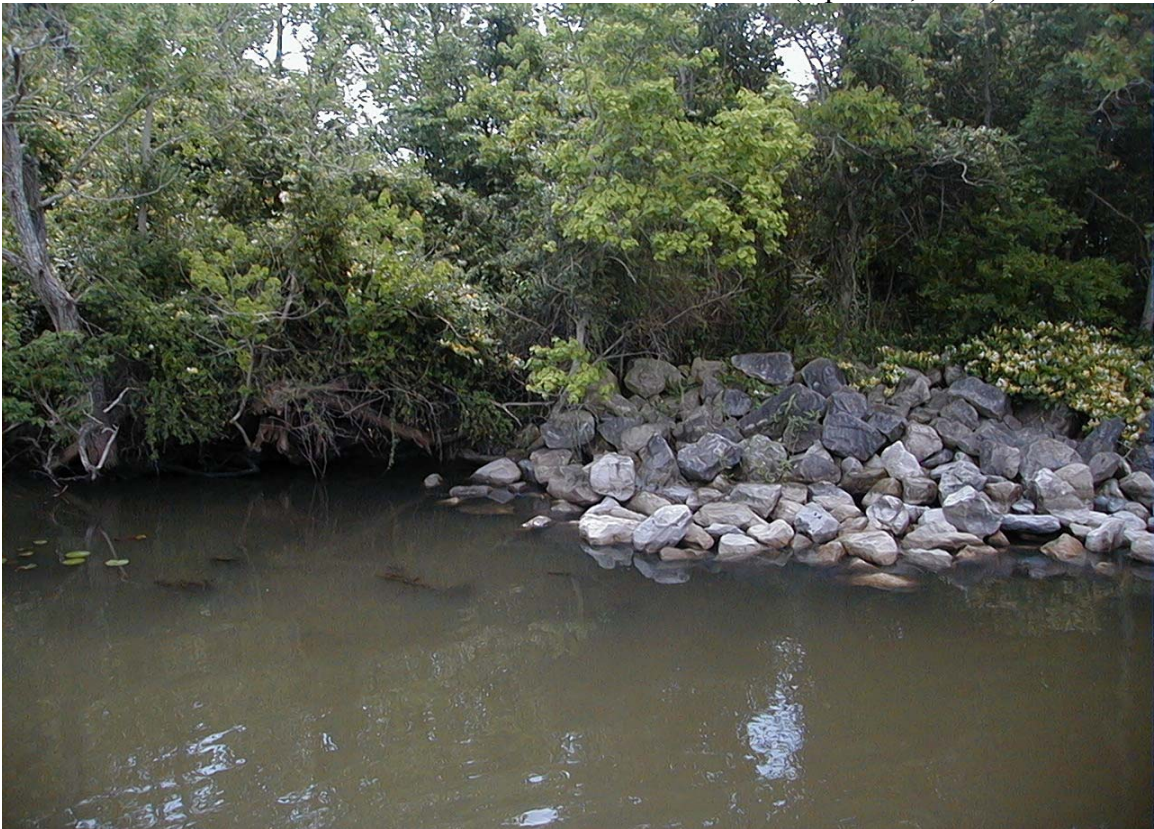
Photo 2—northern tie-in (April 21, 2005)

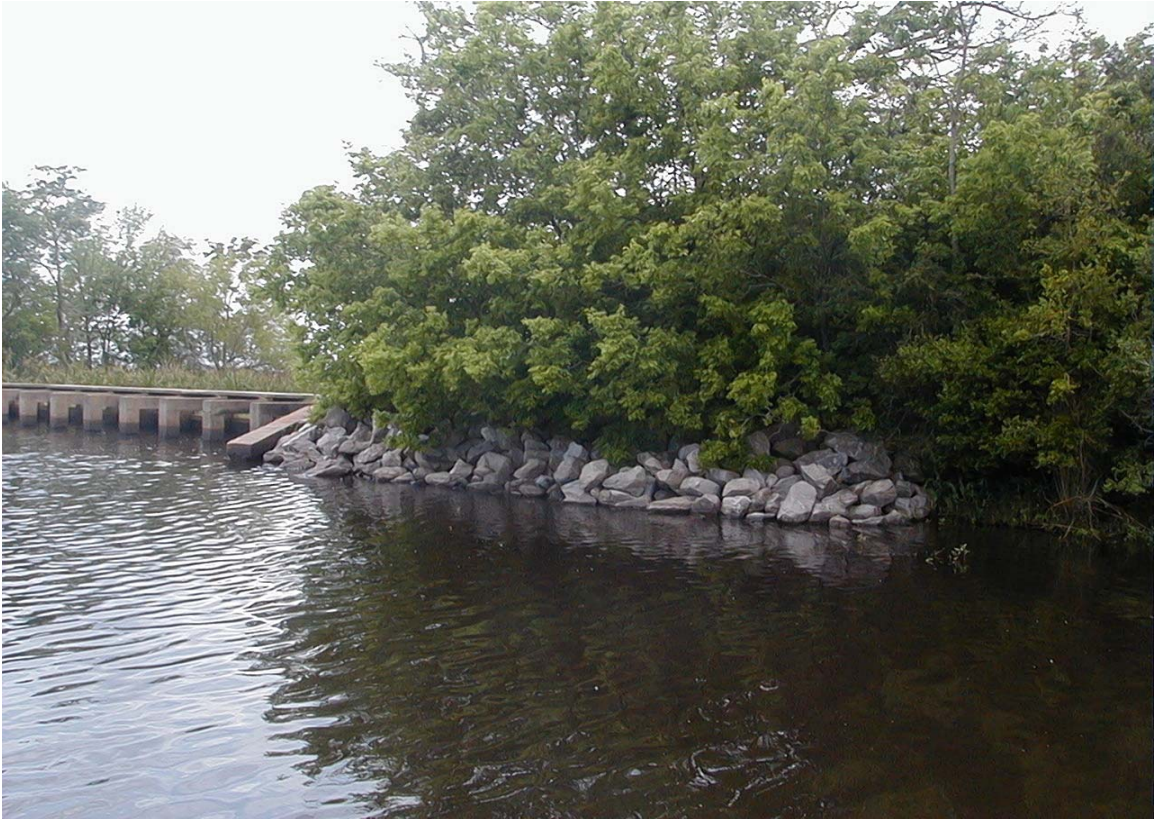
Only weir no. 1 at site no. 3 was inspected due to Hurricane Rita trash and debris field. No maintenance required at this time (Photos: Appendix B, Photos 3-4).

Photo 3—wingwall rock on Beach Canal structure (April 21, 2005)

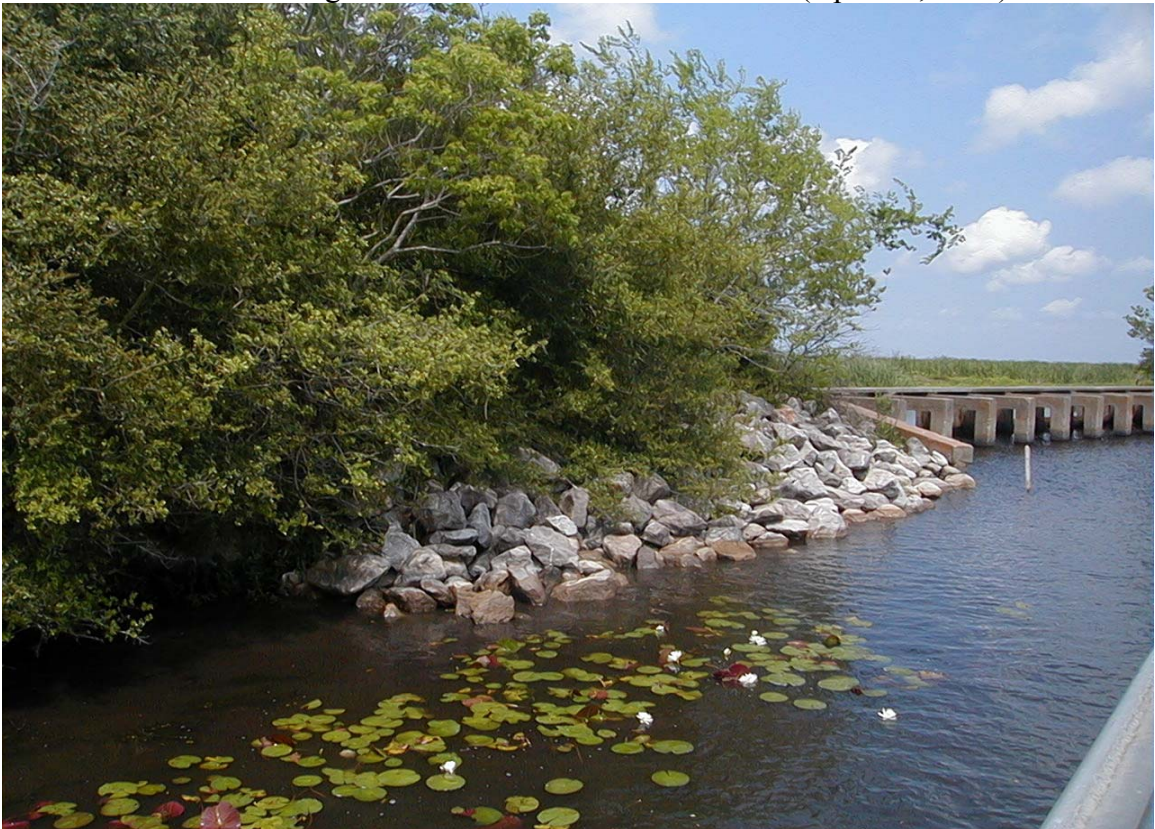
Photo 4—wingwall rock on Starks Central Canal structure (April 21, 2005)
